## Camouflage and Squadron Markings

### Camouflage

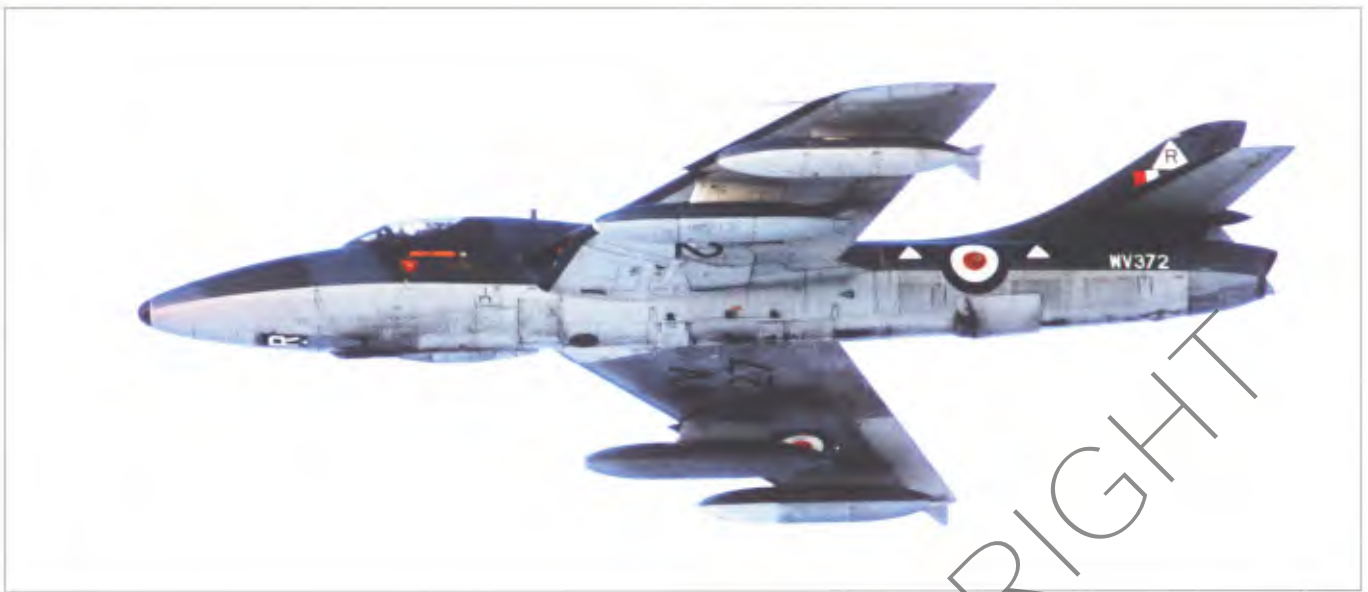
*Hunter T.7 WV372 'R' of 2 Sqn after take-off from Gütersloh, circa 1969/70. Note that the serial number beneath the starboard wing is incorrectly painted as WV327. (Günther Kipp)*

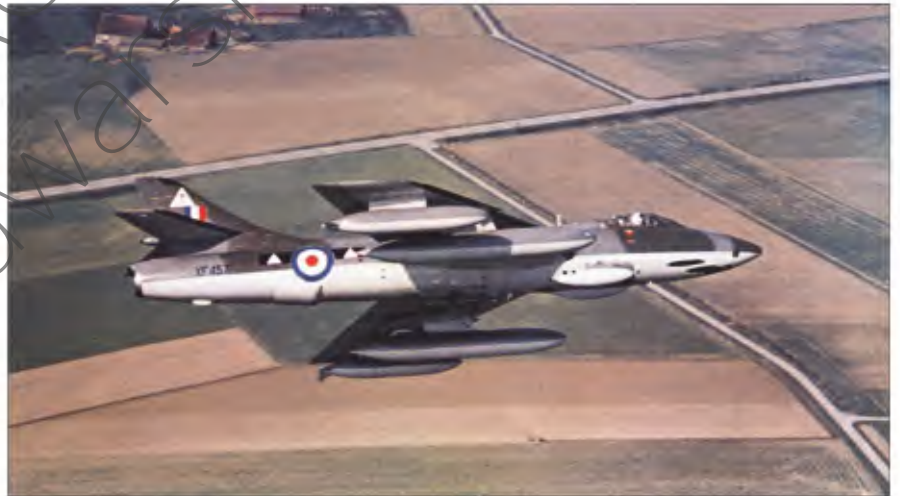
*(Centre Right) FR.10 XF457 'T' of 2 Sqn banking somewhere over the typical terrain of the North German Plain. (MoD)*

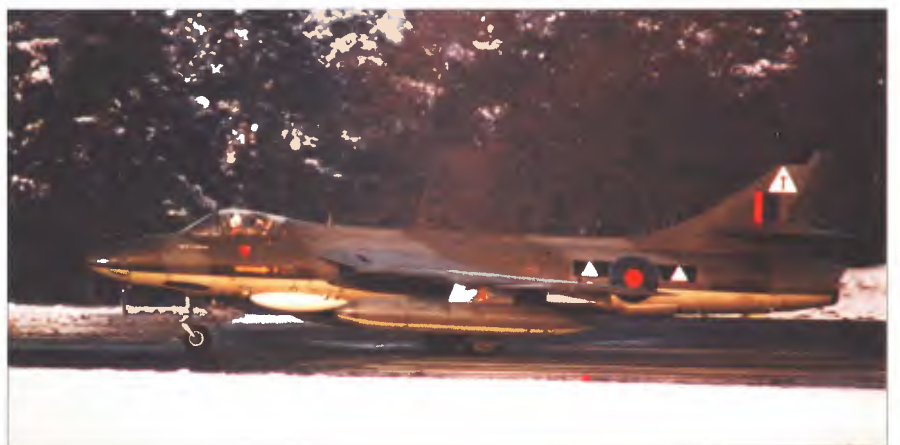
*(Right) The same aircraft, XF457 'T' of 2 Sqn in September 1970 exhibiting an early attempt at 'toning down' long before the so-called B-style roundels, without the white ring, were officially introduced. The experimental roundel returned to its original red white and blue colours after little more than a month. (E. Westersotebier)*
