## Hunter FR.10 Operations

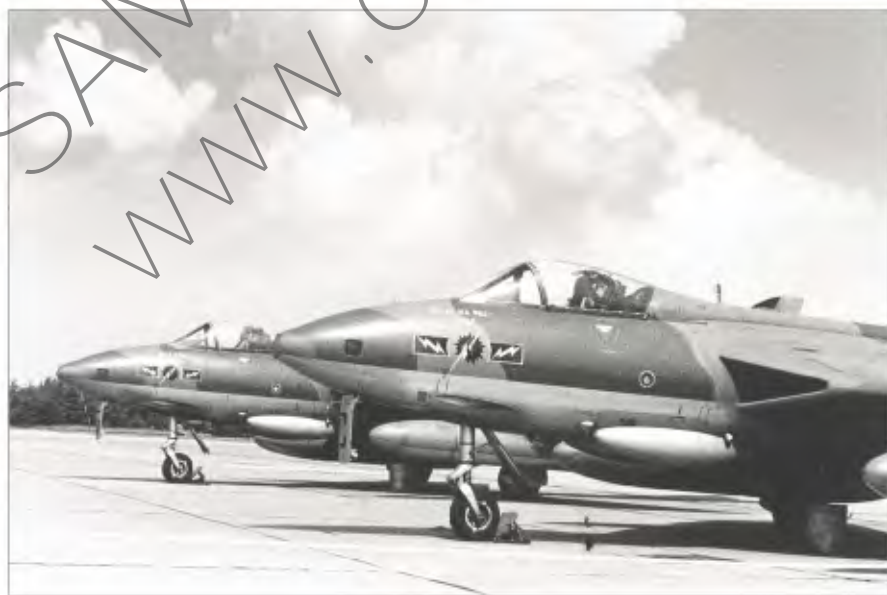
*The business end of Hunter FR.10s 'C' and 'G' of 4 Sqn at Gütersloh in September 1961, when the aircraft still have silver under surfaces and lack the yellow 'Rescue' arrow left of the canopy emergency release of later years. The significance of the 'square' left of the cannon port is unknown. (A.Saal)*

In contrast to the day fighter Hunters the primary task of the Hunter FR.10 was photo-reconnaissance. As the powerful 30 mm Aden cannon had been retained, a secondary ground-attack capability, mainly to be used on opportunity targets and the ability to defend itself, came in handy. The camera nose of the FR.10 housed three Vinten F.95 oblique cameras with lenses of 4 or 12 inch focal length for 70mm film in interchangeable film magazines for 500 exposures. To allow photography at very high speeds and low level, exposure times of up to 1/2000 second could be used at a cycle rate of 4 to 8 frames per second.

The cameras were protected by hydraulically operated shutters which opened automatically when the cameras were triggered. A thermostatically controlled heating element ensured that the system could operate between - 20 and + 50 degrees C. There was no "viewfinder" in the cockpit but pilots
